Designing a safe connection

Safe reefer operations require a receptacle system that exceeds minimum standards in electrical codes

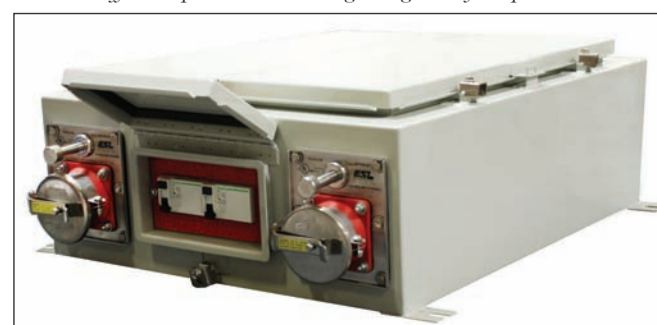
ESL now offers receptacles with an integrated ground fault protection device

A recent development is the incorporation of an equipment ground fault protection (GFP) device on an outlet module to isolate the effect of a phase to ground short. ESL has frequently been asked to incorporate a simple ground fault protection device that can isolate a fault at the receptacle and prevent upstream switch gear from being tripped by a short.

Hellmers advises terminal design engineers to be aware of the fact that reefers generate ground currents during the defrost cycle, so the GFP devices should be selected and set at a value above the defrost cycle ground currents to avoid nuisance tripping.
